Waterloo Biofilter system repairs failed tile bed – saves replacement cost

Article as printed in *Onsite Water Treatment* magazine, December 2007

A Canadian summer camp revamps its onsite water treatment system.

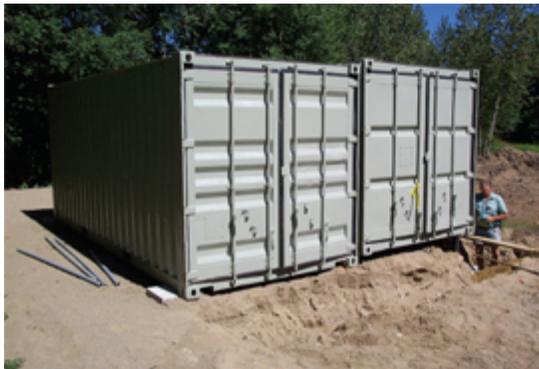
Photo: Pioneer Christian Camp

Renovation occurred while the camp was in operation.

The renovations were carried out while the campground was in continuous operation, which Jowett says was a challenge with a workable solution. “We brought in a pump truck to empty the septic tanks and haul off the sewage. Meanwhile we continued to use the existing leaching beds.” When the new tanks were in place and the feeders were connected, the sewage was directed to the newly installed Waterloo treatment system.

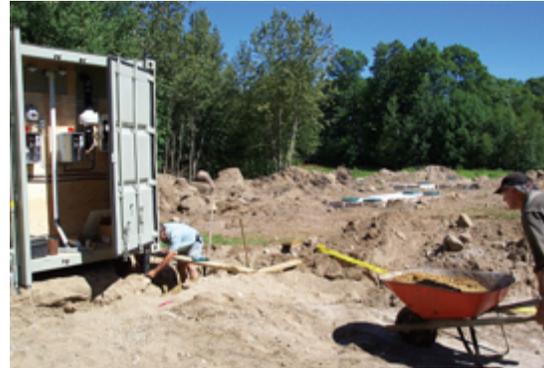
Photo: Pioneer Christian Camp

During construction a pump truck emptied sewage while the fully operational camp used the existing leaching beds.

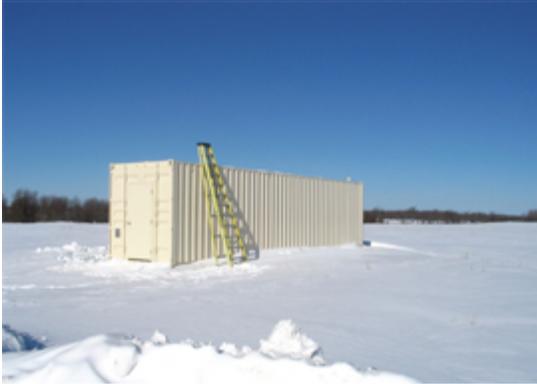
Photo: Pioneer Christian Camp

Despite summer being peak use time, Pioneer Christian Camp also prepared for the long and cold Canadian winter.

Though the peak operation of Pioneer Christian Camp occurs during the summer months, provisions were made for cold Canadian winters. Because the pipe runs are of considerable length, Jowett says small holes were provided for back flow to allow sewage to drain back toward the tank during periods of low flows, preventing freezing in winter. Though, Jowett says, “there is never any standing water in the Biofilter system, the foam itself never dries out.” This, he says, allows biological activity to continue throughout the winter, digesting residual sewage left over from high strength loadings during peak seasons. Jowett says ultimately the bacteria will scavenge on what little nutrient might be present “before going dormant.” In the moist environment, however, “they do not die but revive in the spring” when the flow resumes “and begin treating the effluent.”
